DATE: October 2023

*Cedarwood*  
T R E E C A R E

**TREE CONDITION REPORT FOR  
Henley in Arden Town Council**

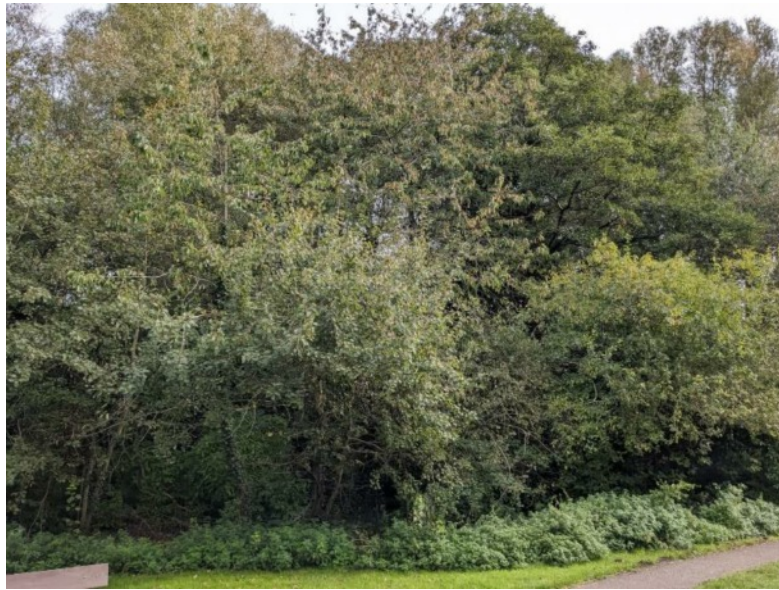
**IMAGE 1** (above) A view of the woodland edge.

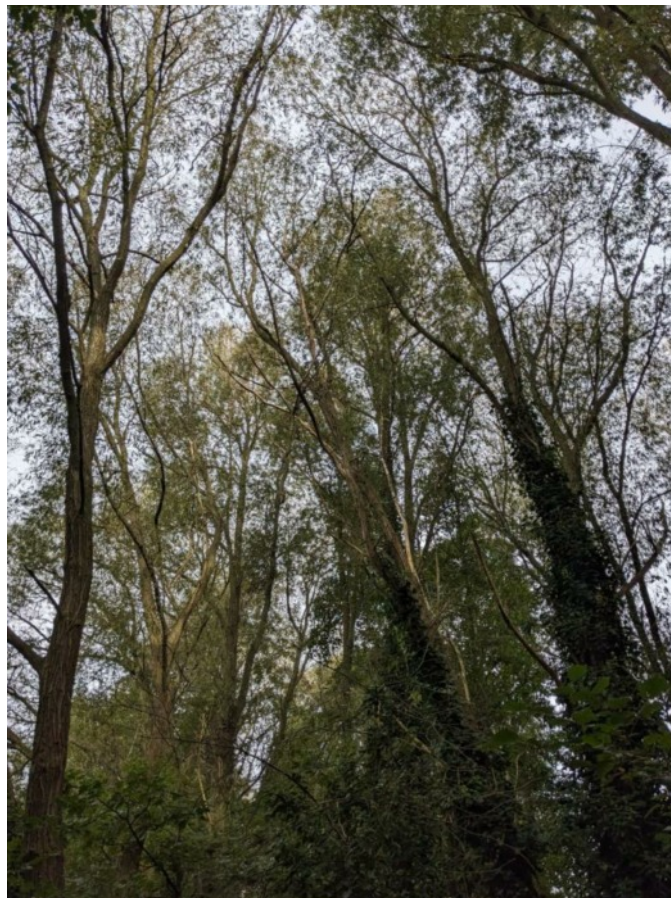
IMAGE 2 (below) Some of the large willows in the woodland edge. They are tall, with extensive dead wood and ivy. Pollarding/coppicing is recommended.

To the west of the park is an area of willow, growing on both sides of the river. Many of these trees are substantial specimens, twenty to twenty-five metres in height. Dead wood and ivy are prevalent. Several of the trees were identified for works in the 2021 survey, work that had not been actioned by the time of the 2023 survey. Willow can become substantial. The timber is not especially strong and there is a risk of branch failure. The individual tree can be managed by being cut to a trunk (pollarding) or to a stump (coppicing) from which the tree can then re-grow. This form of management can enable the tree to have a longer life. This can be shown in the several pollarded willows in this survey which have been able to re-grow from enlarged trunks. It is preferable to arrange for all of the willow trees in this section to be either pollarded or coppiced. An individual tree will grow with trunk and branch strength according to the setting. It is a self-optimised structure. If it is sheltered by neighbouring trees, the trunk is likely to lack wood strength. Removal of neighbouring trees can leave it vulnerable to exposure to prevailing winds, leading to potential branch and trunk failure. The area includes a network of informal paths within the wooded area. There is scope to improve the condition

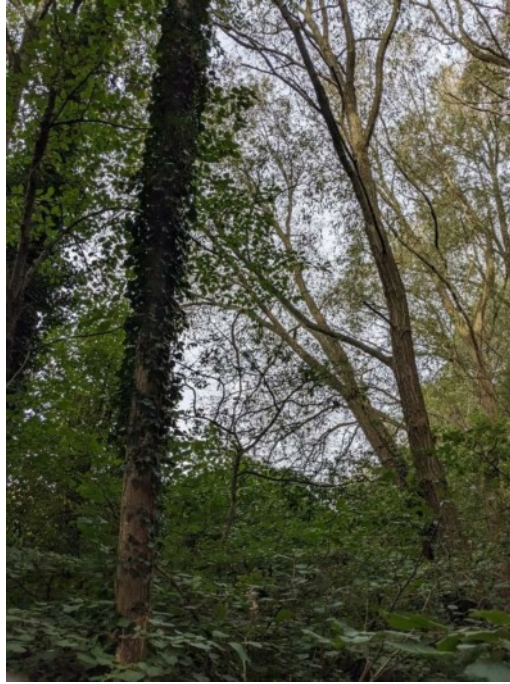
IMAGE 3: Two views of the willows, showing some of the dead wood present.  
IMAGE 4: Note the lack of ground cover. An improved woodland would include ground cover.

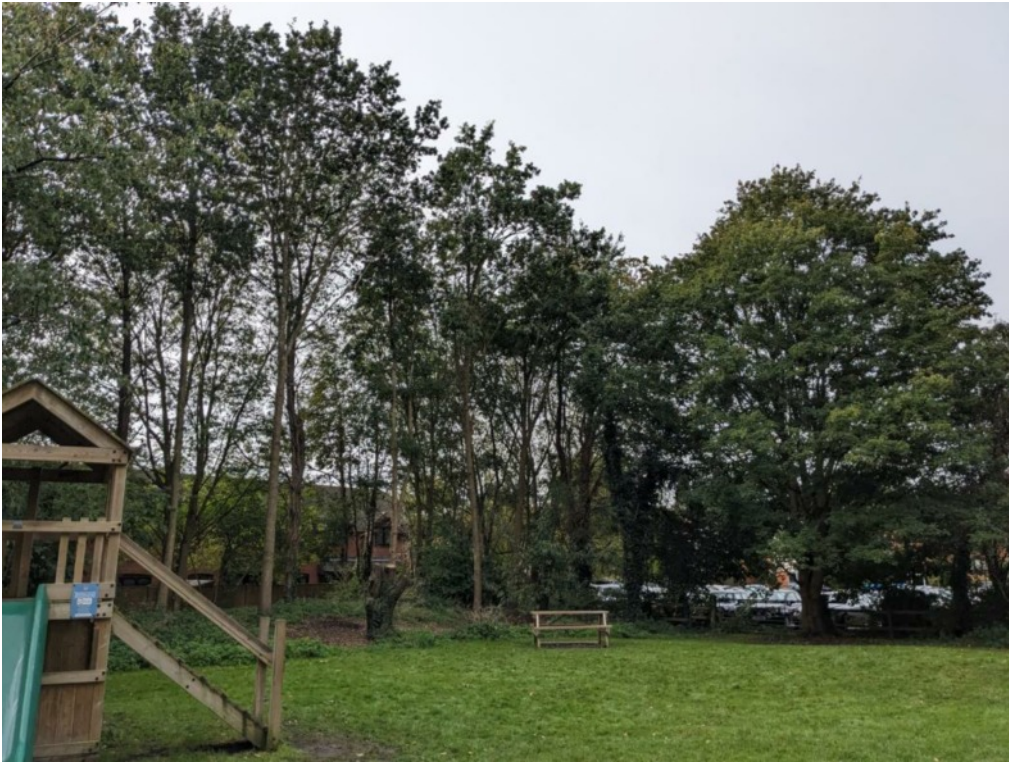
3 is an area with a mix of trees including oak, rowan and apple. It appears to have been planted as a screen to a small group of houses, but the species selection is not suited to this. The several oaks are too close and have become etiolated, so that there are few lower branches, but the trees tower over the nearby gardens. Many of the trees are on a raised ridge, and a maple has been felled with the lower trunk retained as a pollard, but this isn't working, with the regrowth being more like suckers than regeneration. One option is to relandscape the setting, for example, planting a beech hedge and hornbeam which are ideal for screening.

Image 5 Above: Some of the trees in area 3. The oaks are tall and close. They are not screening the houses beyond, but are shading the gardens.

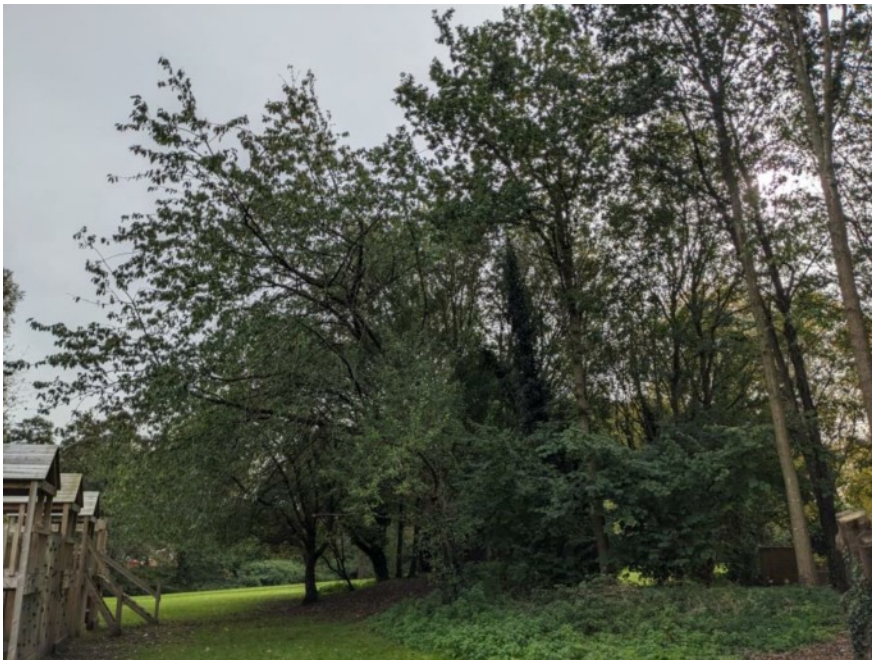
Image 6 Below Another view of area 3. There are trees in decline and some over the play area, which is not ideal.

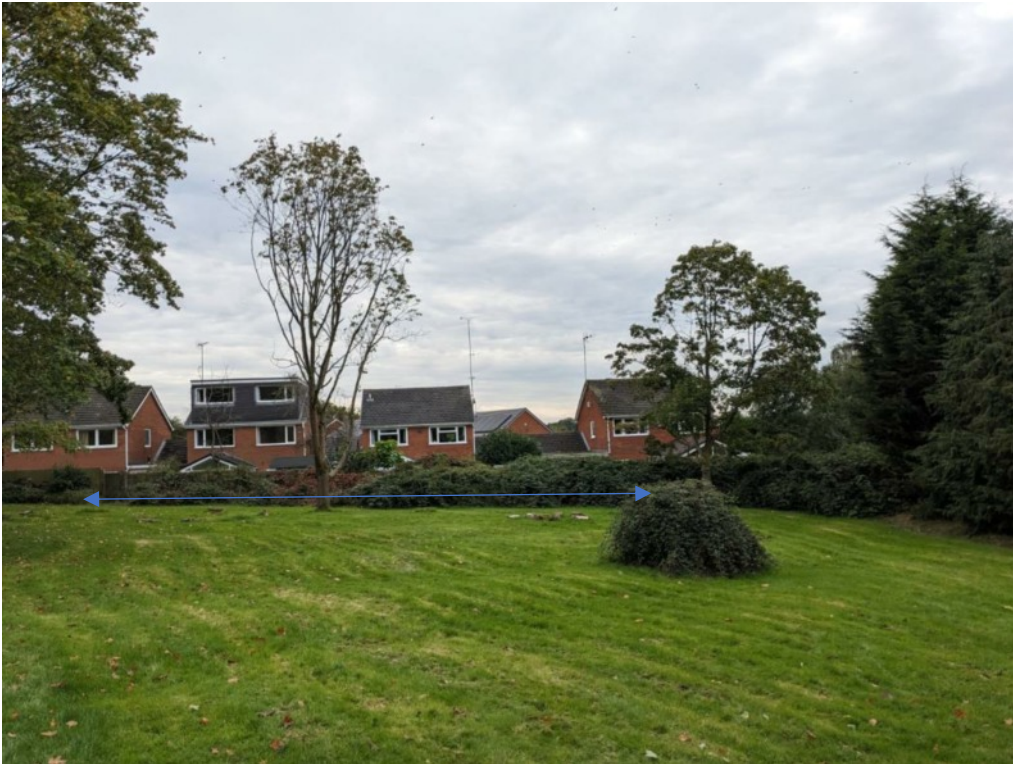
There has been extensive recent felling of trees in this site, mainly on the south-west boundary. Many of the trees are about forty years old, dating from the 1980s. Maples are prominent. A limitation to these trees is that they are not native and offer limited wildlife value. Several of the remaining trees will need to be felled due to their poor condition. There is potential for significant new tree planting here, again planting larger specimens.

Image 7 (above): Jubilee Park, looking south. About ten trees have been felled in the blue area. There is  
Image 8 (below): The woodland edge by the play area. This has not yet been surveyed.

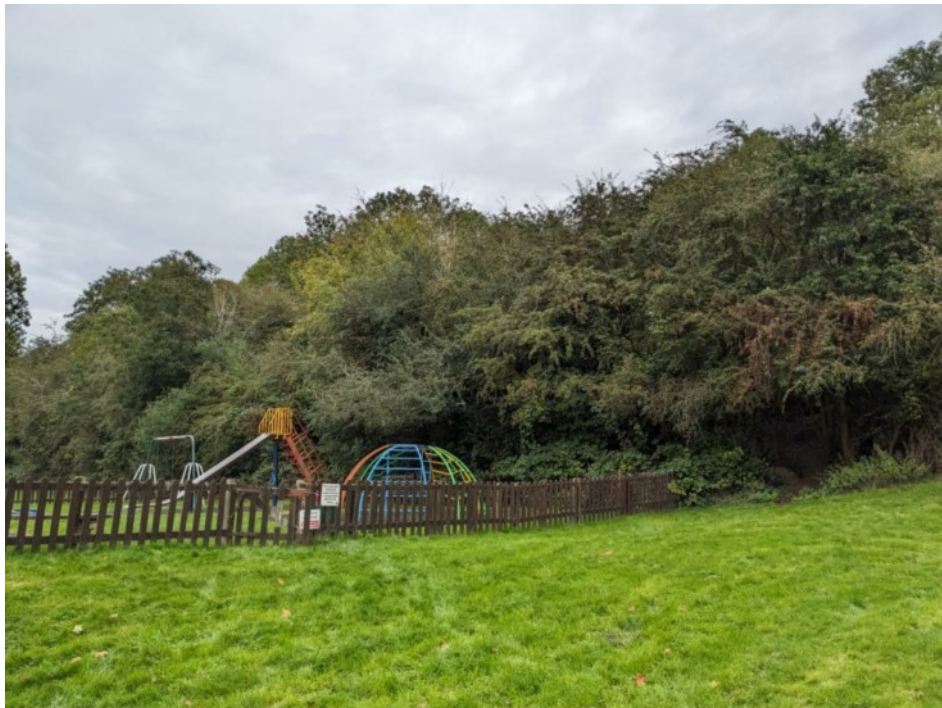
There is a large area of woodland to the east of the site. This has not yet been surveyed.

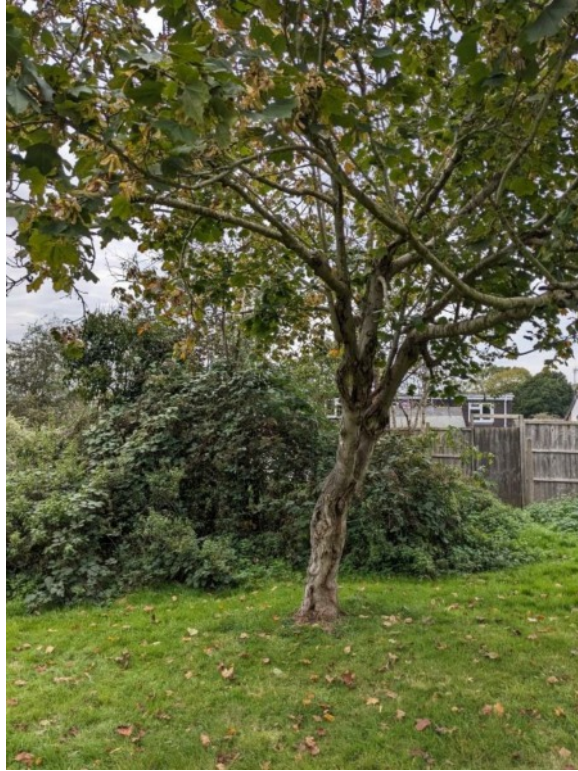
Image 9 (above): One of the trees at Jubilee Park, which is in decline.  
Image 10 (below): A tree has been planted at Jubilee Park. The grass around the base will make it difficult for this tree to become established. A more planned approach is proposed.

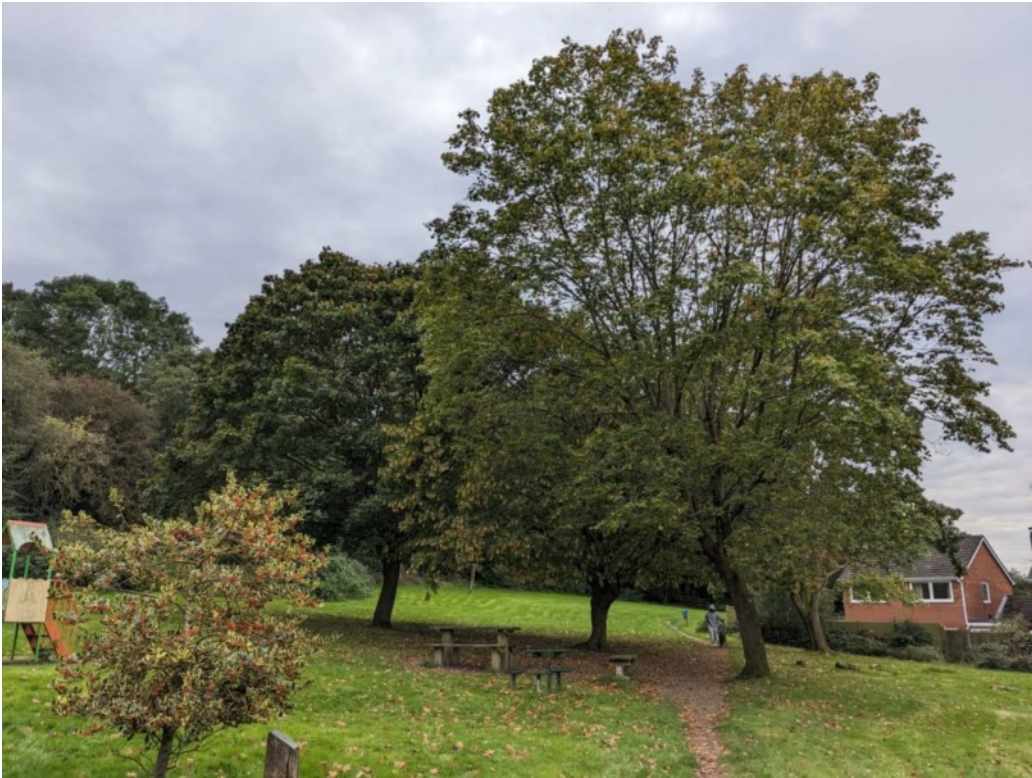
Image 11 (above): Some of the maple trees at Jubilee Park. These are visually prominent. They are not native and offer limited wildlife value.

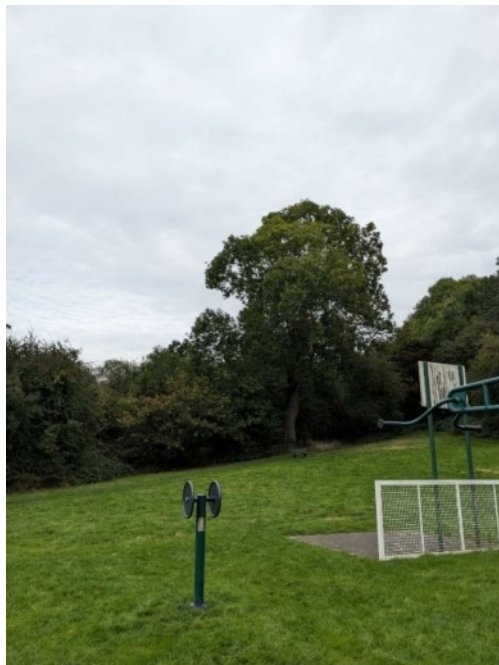
Image 12 (Below): The ash tree on the boundary at Jubilee Park. A more detailed assessment is recommended.
