DATE: October 2023

*Cedarwood*  
T R E E C A R E

**TREE CONDITION REPORT FOR  
Henley in Arden Town Council**

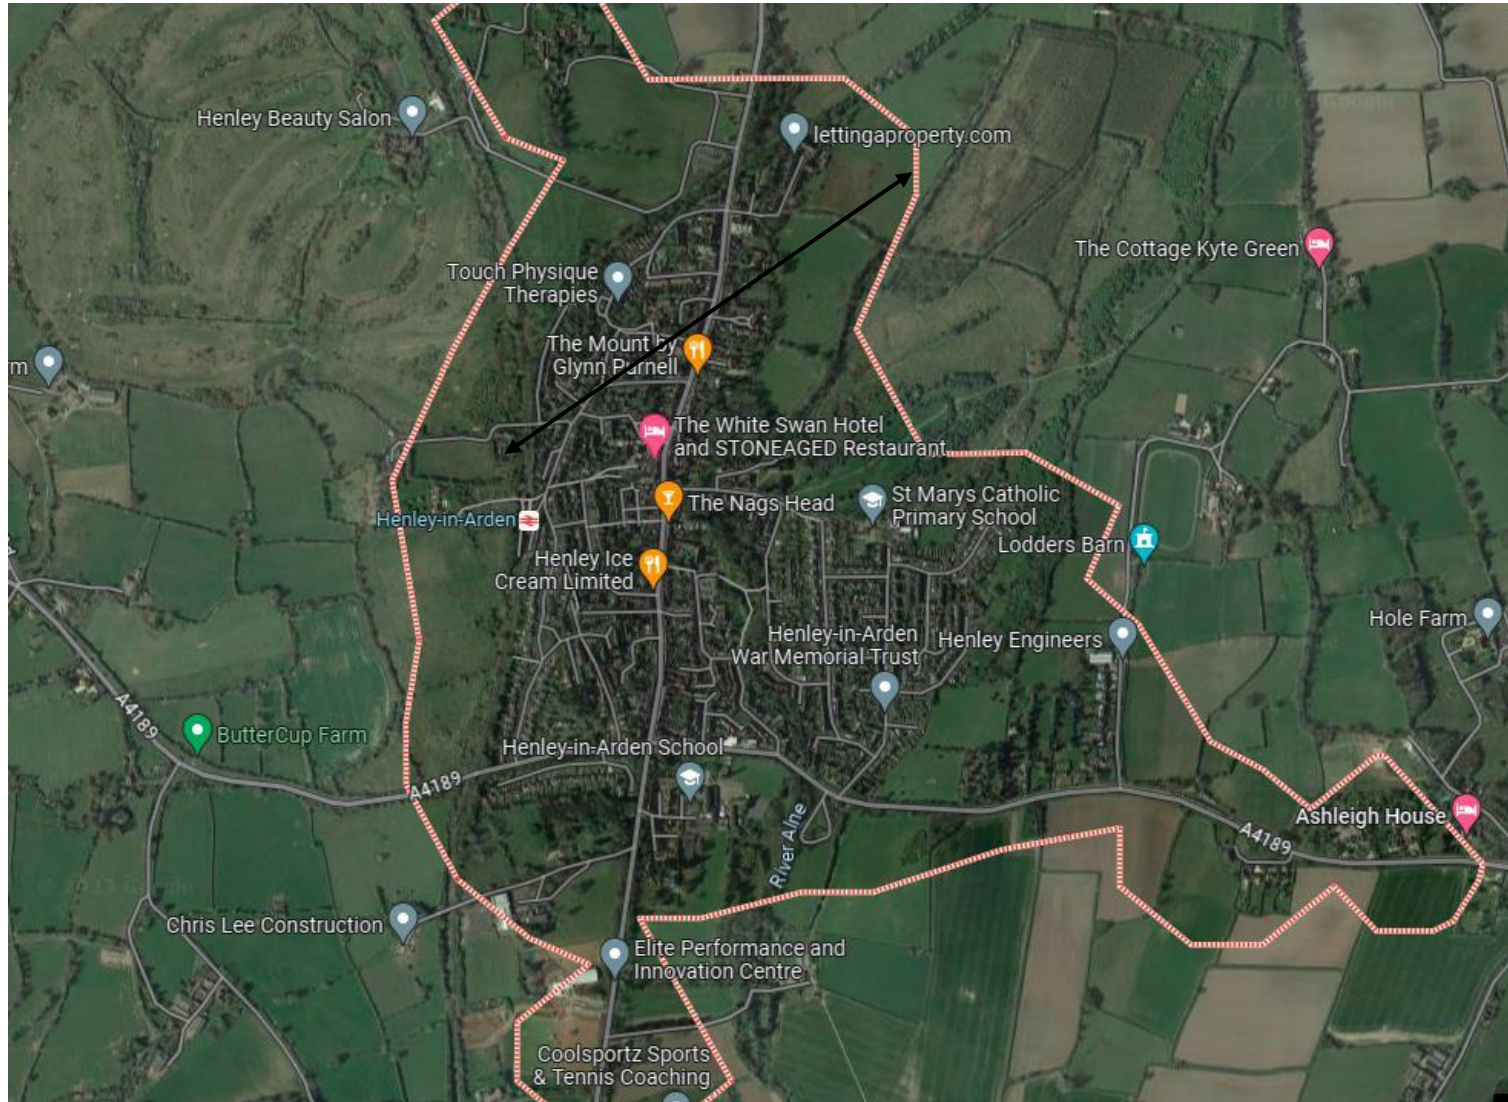
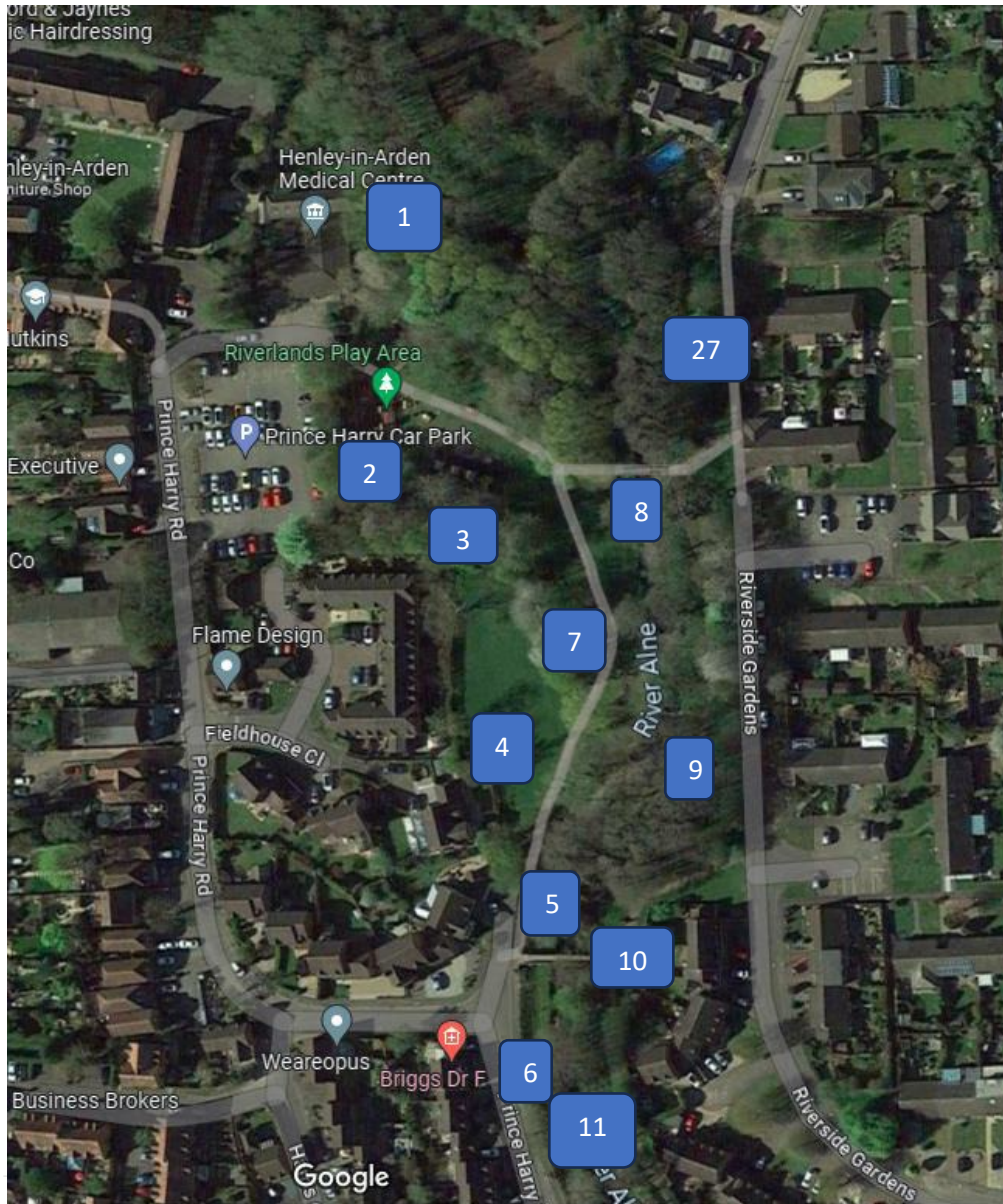
Riverland Gardens

The numbers relate to the order of the survey. Where accessible, all trees were tagged. Note that the trees fronting Riverside Gardens were surveyed last
